**Water and Sanitation Investigation and Improvements
at Escuela Bilingüe Abraham Calazacon
in Comuna Búa de los Tsachilas**

*Summary of work undertaken in Búa between 1st August and 7th September
2007.*

*Report prepared by Nick Bundle for Fundación Yanapuma
on 13th September 2007*

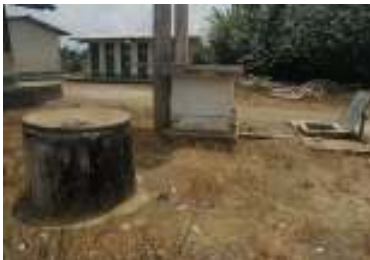
Fig 4. Headstone with cover.
Visible beyond the well are the cistern and housing for the pump that was used to pump water from the cistern to the water tower.

4. Whilst usually in place, there have been occasions when the well was observed without the concrete lid. This is one possible way in which contamination can enter the well.

5. The headstone is made of breeze blocks, the inside being unsealed and with some small holes noticeable that extend from the outside into the interior of the headstone. Cockroaches have also been observed appearing from the holes in the interior of the headstone.

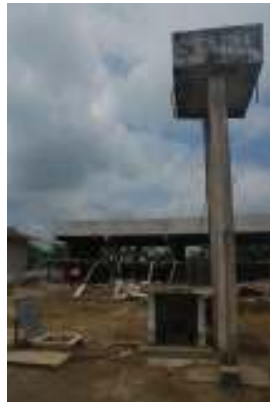
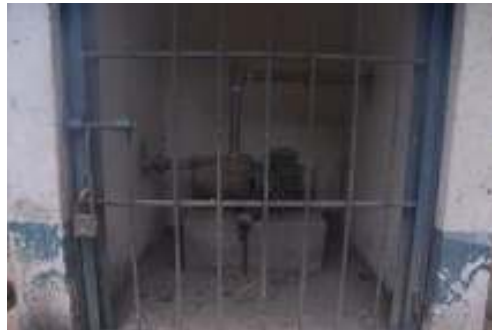
Fig 5. Water tower, pump housing and cistern as viewed from the opposite side as fig 7. The design was considered to be unsafe by Guillermo after it was observed to sway when the open-topped concrete tank was full of water.

Fig 6. Close-up view of the pump housing.

The fears about its instability were discussed with the two CoopEcuador engineers present to oversee the building of the new classrooms, and they advised that the base of the tower be reinforced by digging a 30cm wide trench around it and filling it with stones/concrete (fig 17,18).

This advice was duly taken, but there is still a tendency for it to sway from side to side slightly. People are happy that it is not dangerous however (further assurance from the engineers) and the plastic tank is in place on top of it, with a permanent ladder in position (fig 19) to allow easy access to the tank for treatment of the supply with chlorine.

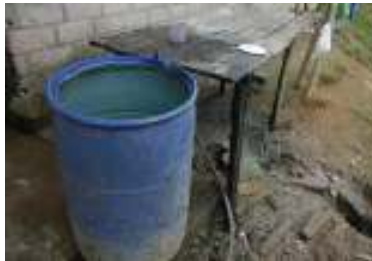
Fig 7. Drum and outlet pipe from pump behind comedor. The table is used for washing up. Some grey water puddles in the uneven surface below the table.

9. Washing up of all the dishes from the comedor, as well as those of the 'free³' lunch service, take place at a rotting wooden table (fig 7), which is a great source of flies in itself. Underneath the table can be found pools of water and various debris, including food remains and rubbish. These areas are perfect breeding grounds for mosquitoes, with Dengue and Malaria being real risks in the wet season. The water that does escape down the bank from here tends to accumulate in a muddy, slimy area below which too would act as a perfect breeding site for mosquitoes.

The rotten table was broken down and removed, and the floor re-done and finished on an incline (for drainage) with channel in place to ensure drainage of rainwater. The channel is in fact an extension of the existing rainwater drainage channel that drains rainwater falling from the roof of the nearby classroom. A soakaway pit similar to that used for the hand washing grey water was dug to serve the grey water generated from dish washing behind the comedor. This pit is located

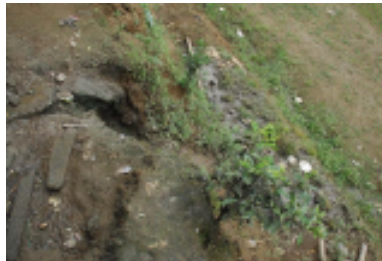
Fig 8. Grey water draining down from the washing station and accumulating on the ground below.

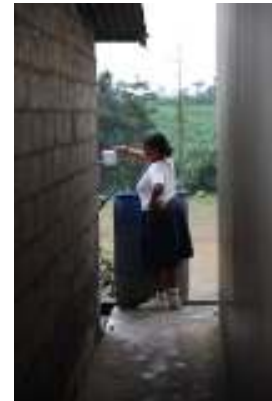
Fig 9. Student scoops water from the drum for hand washing.

8. Lack of a tap means that the water in the drum quickly becomes sullied as students dip their hands and at times heads into it. This water is then used for cooking, washing of dishes and sometimes even drunk directly.

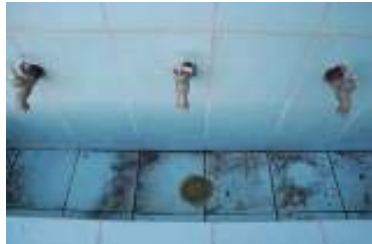
Fig 11. New taps installed, with plastic mesh protecting the plug hole from blockage by debris.

The taps in the hand washing station were replaced (fig 11), and one of the existing inlets to the general toilet block plumbing (located directly below the hand washing station) was connected to the new pipe come down from the water tower so as to provide water to the taps. The toilet block is plumbed in a loop with two inputs serving the toilet cisterns and hand washing station. All cisterns were turned off at their taps. This was to avoid:

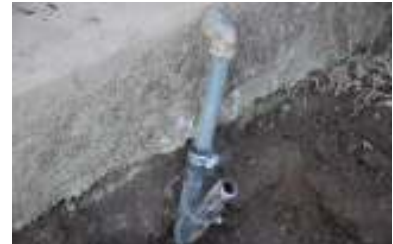
Fig 12. Simple method of blocking the second inlet to the toilet back plumbing to 'close the loop' and stop leakage/pressure loss.

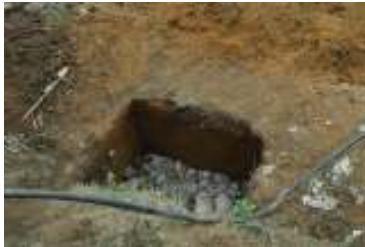
Fig 13. Soakaway pit under construction

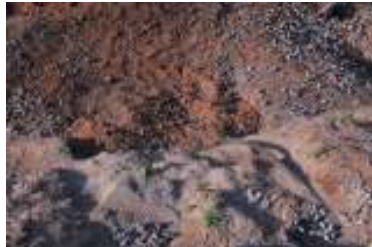
Fig 14. Finished soakaway back filled with excavated earth.

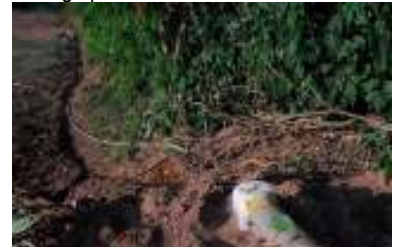
Fig 15. Water bottle is used as a reducer to send the septic tank effluent down a length of recycled water pipe, which follows the line of a trench.

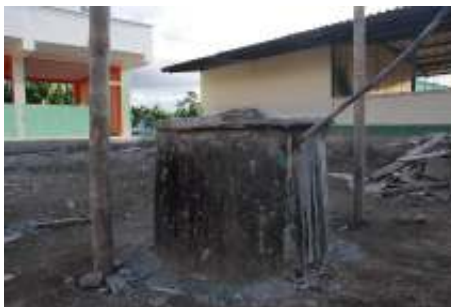
Fig 16. Well with the outlet pipe exiting via a hole in the side of the headstone.

This sealing work was, leaving the well in an apparently well improved condition. Guillermo and the fathers decided to have the pump outlet pipe coming up out of the side of the headstone, rather than being buried as it was before (fig 16).

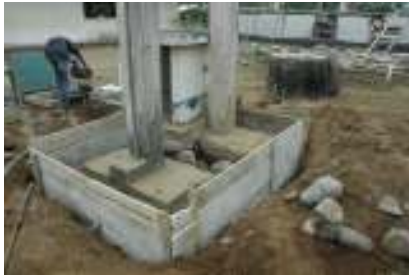
Fig 17. The trench is dug ready for concrete to reinforce the base

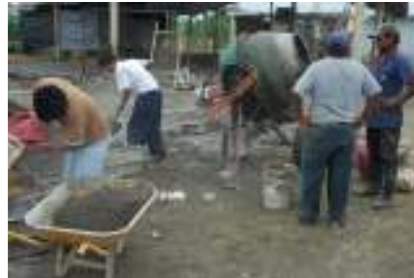
Fig 18. Minga, with assistance from the CoopEcuador labourers and machinery to mix the cement.

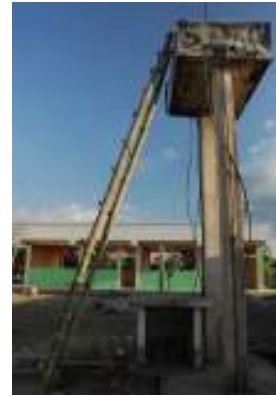
Fig 19. Ladder in position providing access to the tank for water treatment.

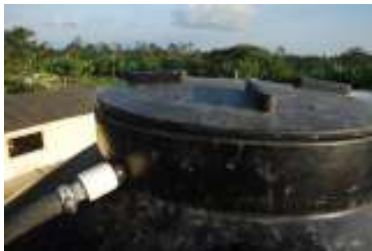
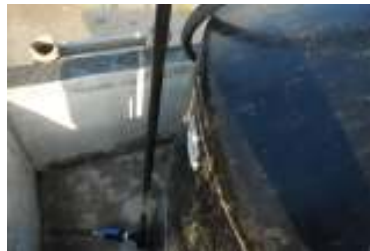
Fig 20, 21. Photos taken from inside the top of the water tower showing the inflow and outflow connections to the tank.

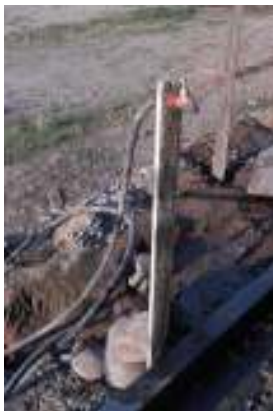
Fig 22. Temporary standpipe style tap, positioned above the rainwater drain.

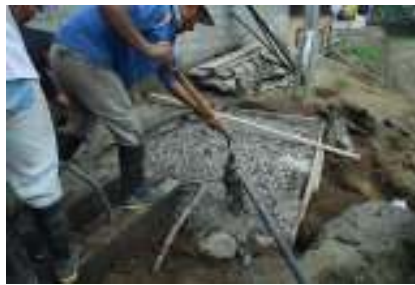
Fig 23. Minga. The base is filled in and concreted.

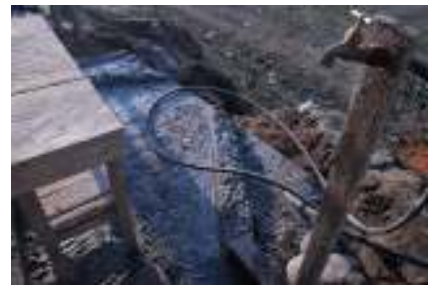
Fig 24. Finished base, on an incline with rainwater drainage channels. Temporary table for washing up in lieu of a sink. The drainage pipe that leads to the soakaway below is visible

- The rainwater channel needs further development to take the water away from the bottom of the bank where it will accumulate. Jorge Guzner who was involved in the improvements here has ideas in this regard, so follow up with him is required along with the arranging, through Guillermo, of another minga to finish the job.

- The area of accumulation below needs to be thoroughly cleaned of litter and debris and kept clean, along with the rainwater channel above.
